Manhole Inspection Summary

Manhole # S09CC2027MH

Insp Date: **10/25/06 2:14 PM**

Location Address: **5900 GREENSPRING AVE**

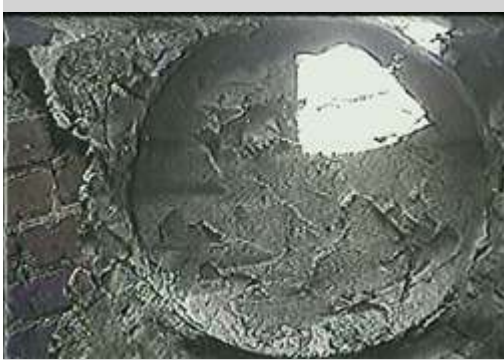
Defect

Frame leaks. Adjustment deterioration, loose brick and infiltration. Barrel infiltration.

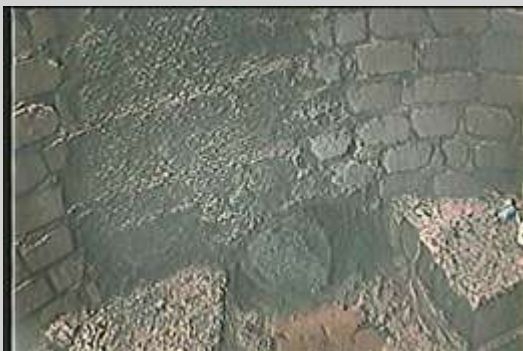
Pipe In @ 3 O'Clock

12 in. Circular Gravity Sewer

Rod and Bar (Angled)

Infiltration: **None** Pipe Seal Cond: **Unknown**
